DOUBLE SCOPE INSPECTION REPORT

1361 Florida Ave NE
Palm Bay, FL 32905

City of Palm Bay Facilities

07/01/2024

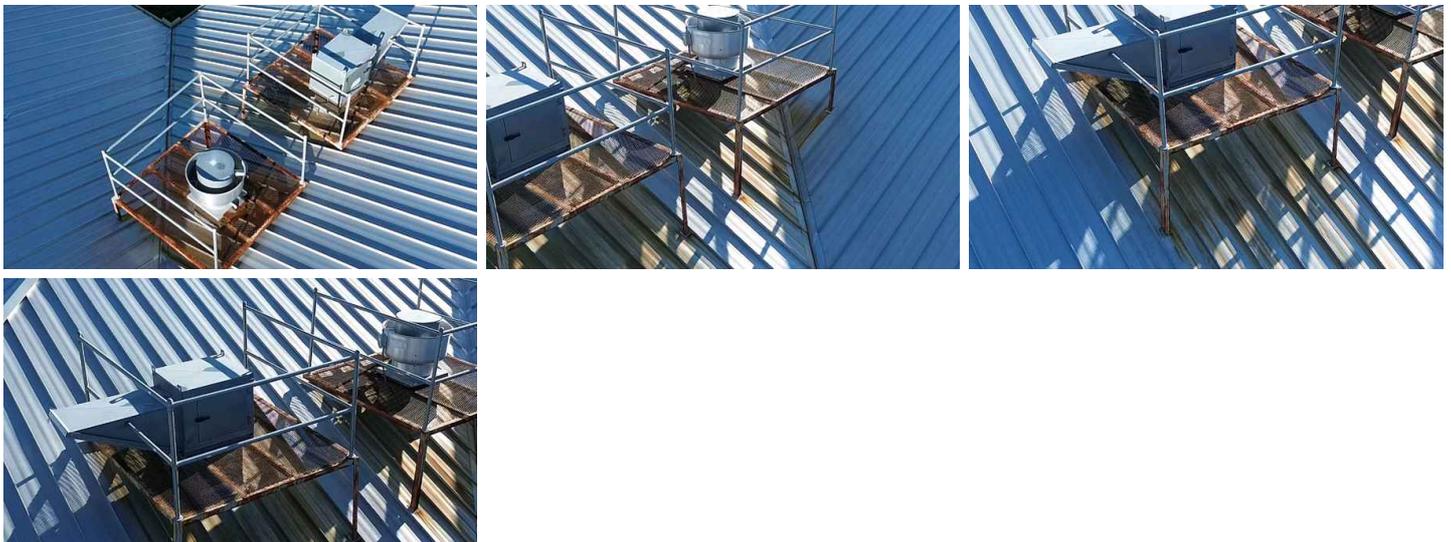
METAL EXTREMELY RUSTED

The metal shelving at roof shows evidence of excessive rust/deterioration. Recommend monitoring. It is recommended that this area be treated to prevent further deterioration.

Contact a qualified professional.

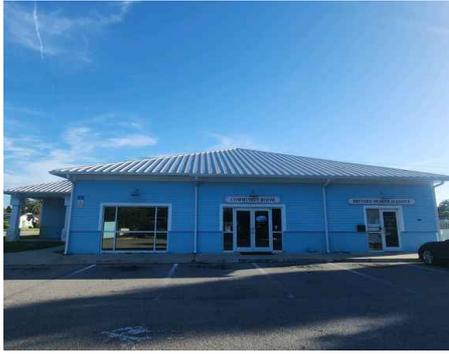
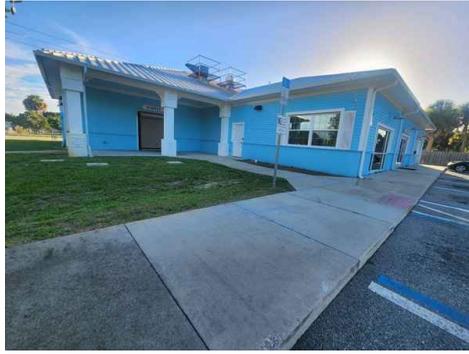
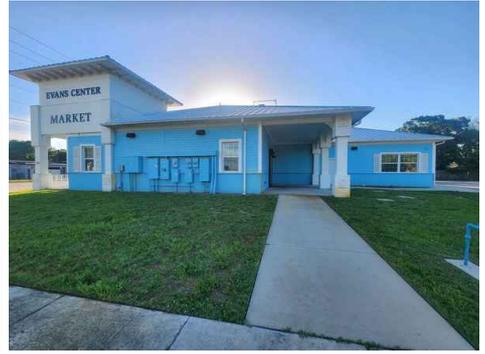
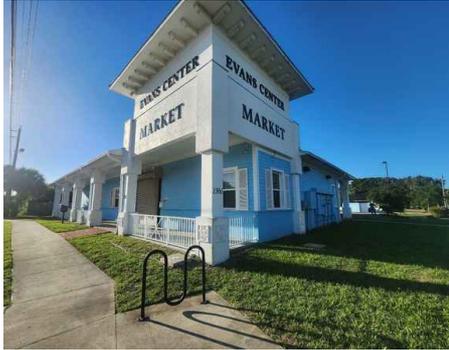
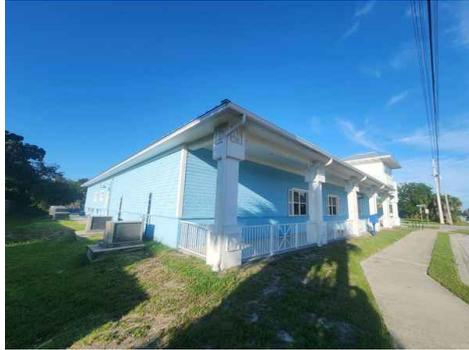
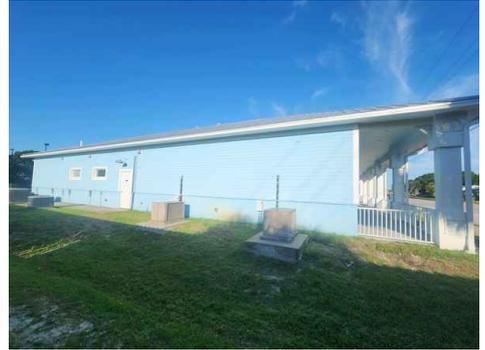
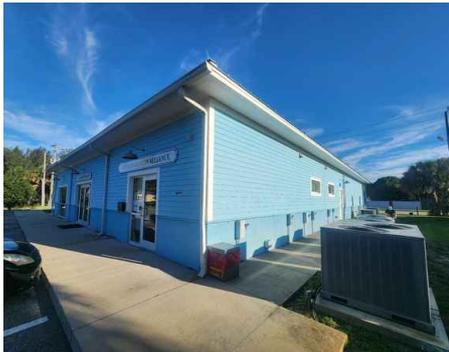
Vegetation, Grading, Drainage & Retaining Walls: Grading Is Satisfactory

The grading around the home is generally satisfactory at this time. Monitor and maintain the grading over time to promote drainage away from the foundation of the home.

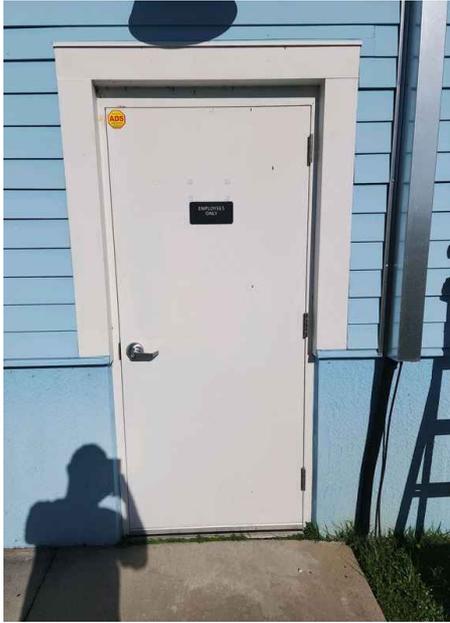
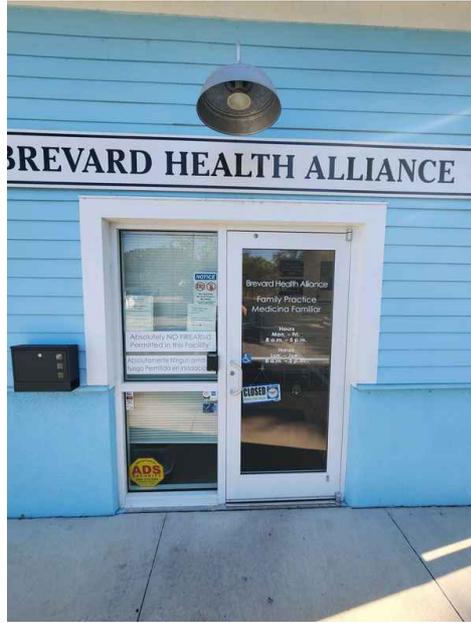
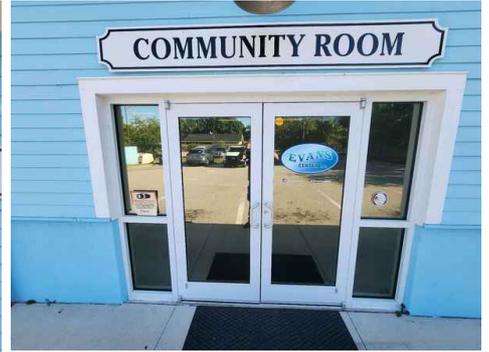
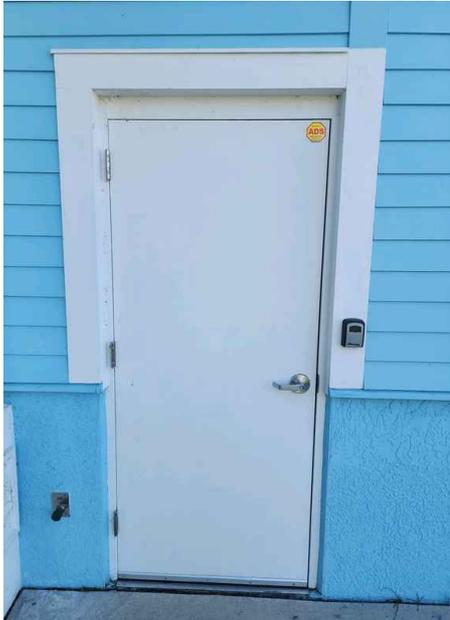
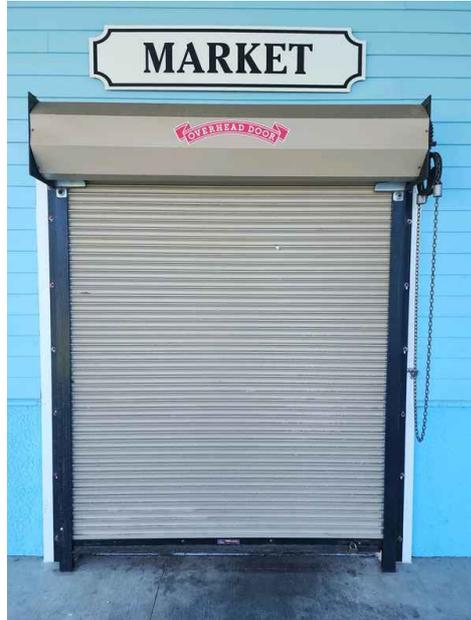
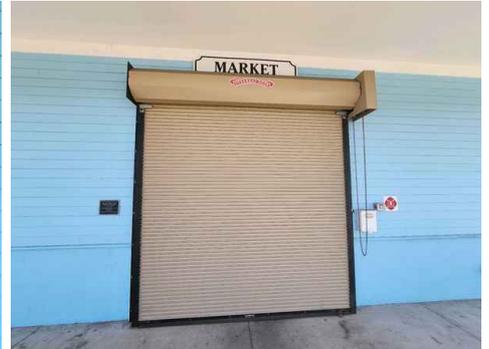
Exterior Doors: Door Operational

Doors are operational at the time of inspection.

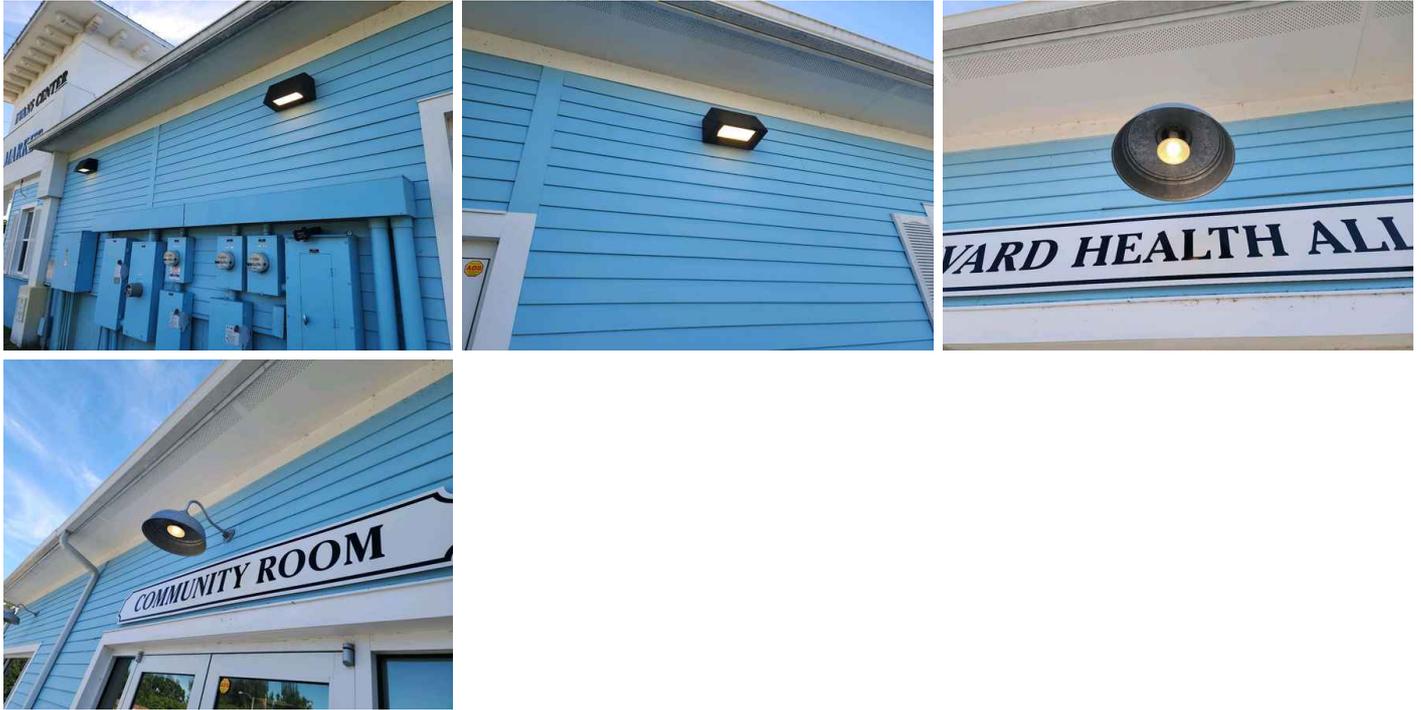
Eaves, Soffits & Fascia: The eaves, soffits, and fascia in good condition

The eaves, soffits, and fascia in good condition. This is an overall view, not including defects listed

Lighting Fixtures, Switches & Receptacles: All Receptacles Good At The Time Of Inspection

Other than what is noted, all receptacles are good at the time of inspection.

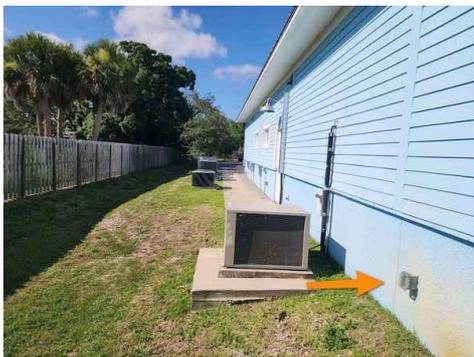
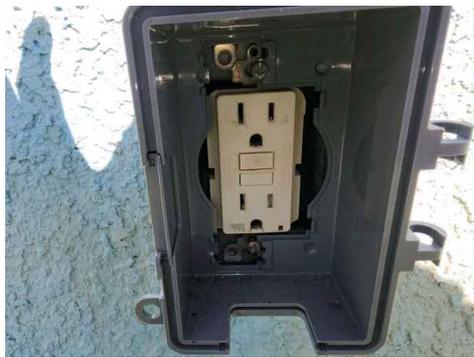
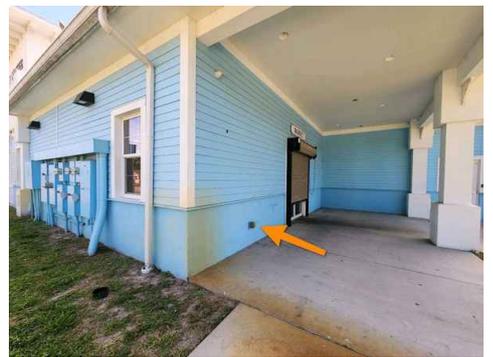
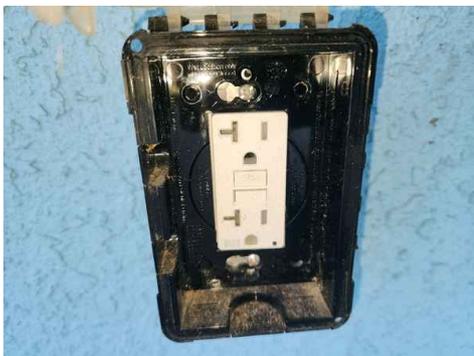
5.8.1 GFCI

GFCI NOT FUNCTIONAL

When tested, the GFCI (Ground Fault Circuit Interrupted) receptacle did not function properly. **(Won't reset & worn)** This is an indication of a defective or improperly-wired safety device. A qualified professional needs to make repairs or modifications as necessary to meet electrical safety standards.

Contact a qualified professional.

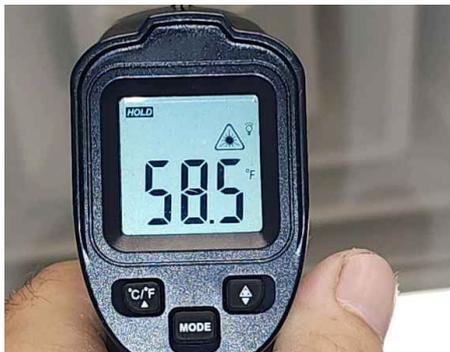
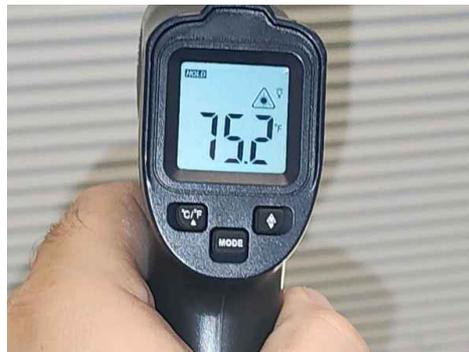
Temperature Differential: Normal Range

An ambient air test was performed on the cooling system to determine if the difference in temperatures of the supply and return air is between 15 degrees and 22 degrees, which indicates that the unit is cooling within industry standards. The return air temperature was 75.2 degrees, and the supply air temperature was 58.5 degrees, for a temperature differential of 16.7 degrees. This indicates the temperature drop is within normal range.

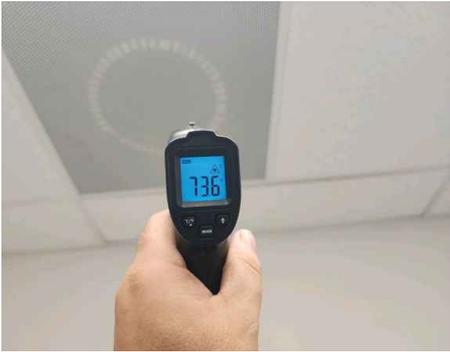
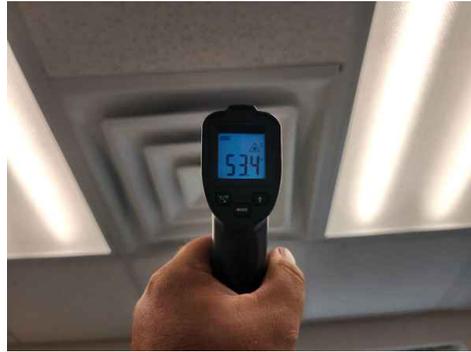
Temperature Differential 3: Normal Range

An ambient air test was performed on the cooling system to determine if the difference in temperatures of the supply and return air is between 15 degrees and 22 degrees, which indicates that the unit is cooling within industry standards. The return air temperature was 73.6 degrees, and the supply air temperature was 53.4 degrees, for a temperature differential of 20.6 degrees. This indicates the temperature drop is within normal range.

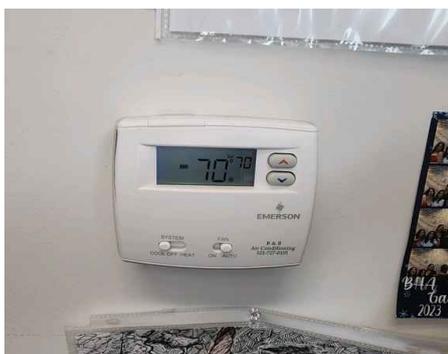
Normal Operating Controls: Thermostat is Good

The thermostat appears to be in good working order and responded properly to heat and/or cool settings. Note; Digital thermostats will usually have several custom settings & functions that can vary widely from model to model. Testing of these special features is beyond the scope of a home inspection and we made no attempt to evaluate any of these added features.

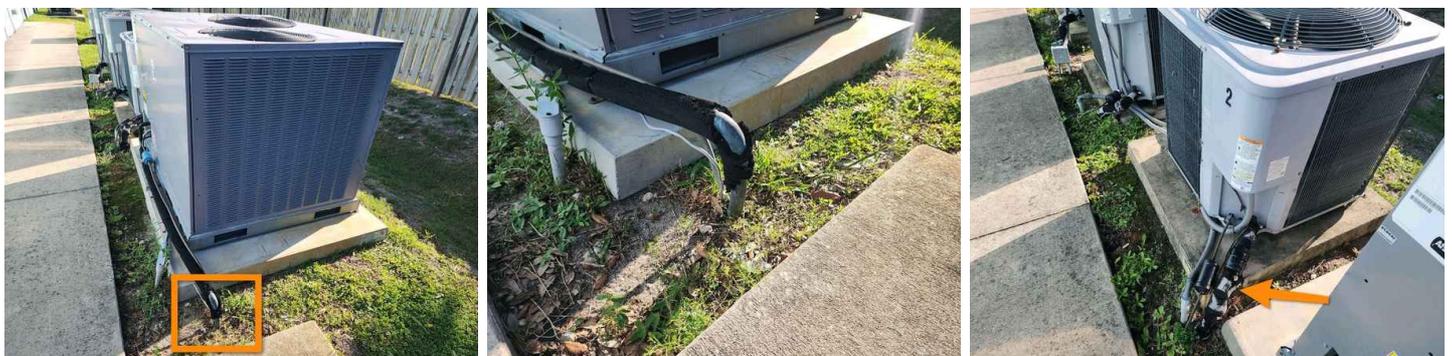
6.3.1 Condenser Equipment

INSULATION MISSING OR DAMAGED

Replace the missing/damaged pipe wrap insulation on the suction freon line at the condenser unit to properly insulate the pipe which will maximize energy efficiency of the system and restore it to the industry standard to which it was installed.

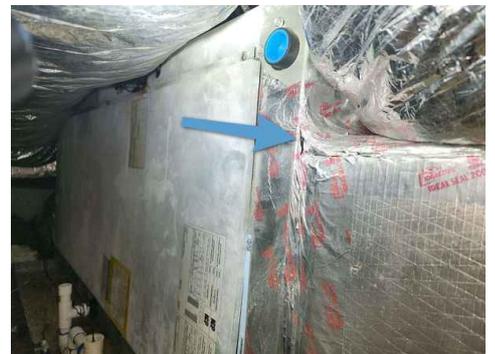
AIR LEAK AT SUPPLY DUCT

Repair the air leaks where the air supply duct board plenum attaches to the air handler. To stop the loss of heated/cooled air. Repair/replacement of the tape and/or mastic sealant will improve the energy efficiency of the home.

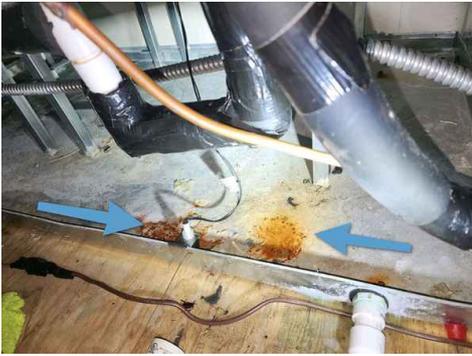
6.8.1 Air Handler Equipment 3

DRIP PAN HAS CORROSION

Drip pan for the air handler has corrosion. No active leaks at the time of inspection. This is noted for your information. Replace as needed.

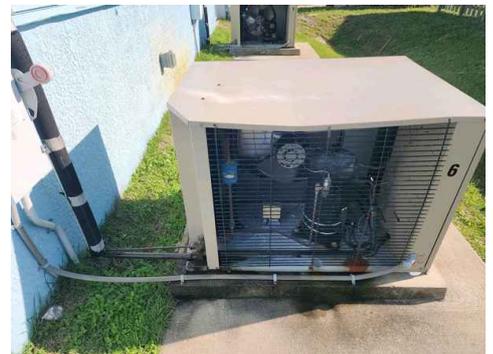
UNUSUALLY NOISY

Compressor started and operated but unit was unusually noisy. Recommend licensed HVAC contractor evaluate.

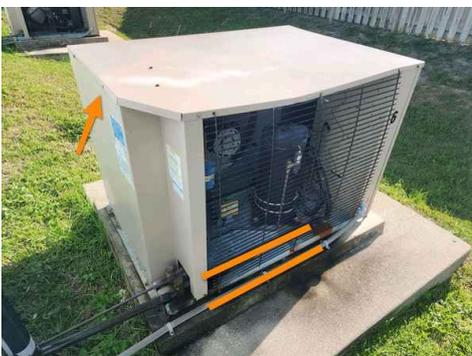
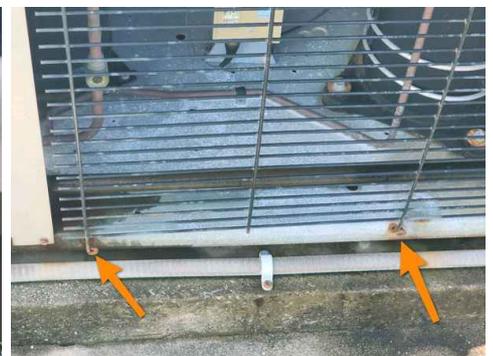
6.16.2 Condenser Equipment 6

SCREWS MISSING FOR HOUSING AND CAGE

Screws missing for housing and cage. This recommended that these be added to protect unit and person from coming in contact with the fan blades

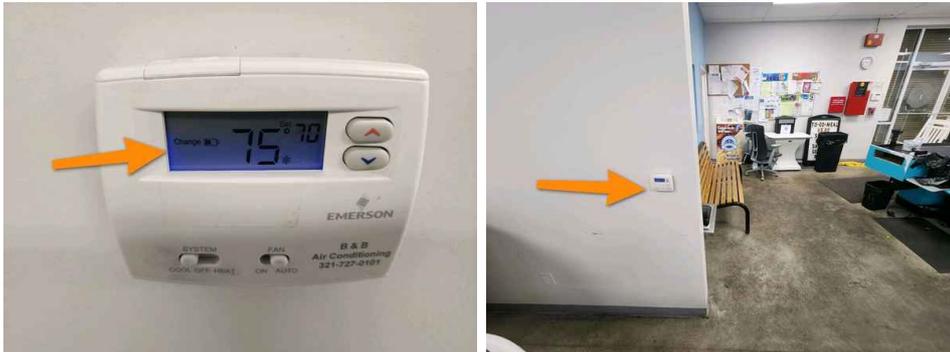
6.18.1 Normal Operating Controls

BATTERY REPLACEMENT NEEDED

Thermostat has "replace battery" warning. Replacing battery should resolve this issue. Failure to replace batteries can cause HVAC not to work properly

Contact a handyman or DIY project

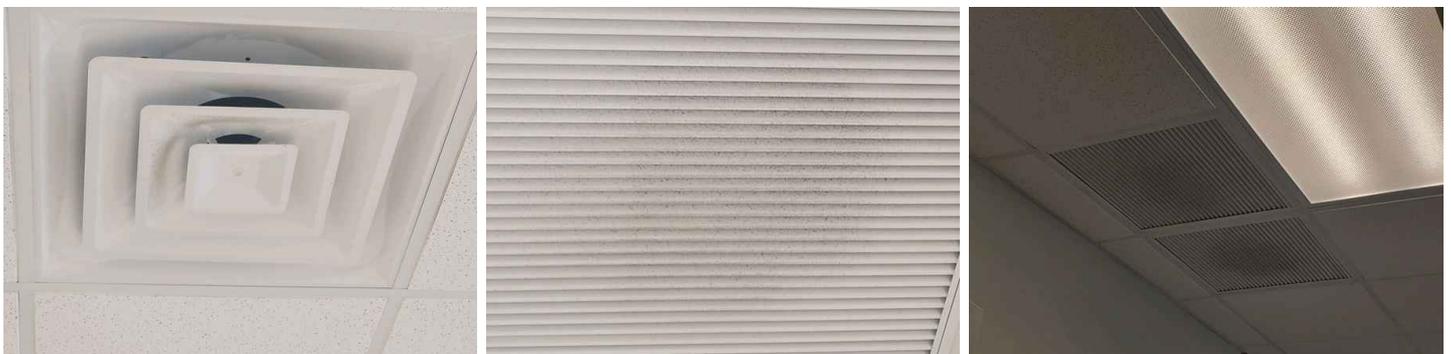
DIRTY VENT COVERS WITH STAINING/MICROBIAL GROWTH

A/C vent cover throughout the building are dirty. In some areas the ceiling tile around the dirty vent covers have dry condensation stains that can be painted. It also appears to be microbial growth on the ac vents and microbial growth can form on any surface in an environment that lacks sufficient ventilation or has high levels of humidity. Clean with vinegar or bleach water solution. Recommend cleaning upon move in for cleaner air flow.

Multiple vent covers throughout the building

Contact a handyman or DIY project

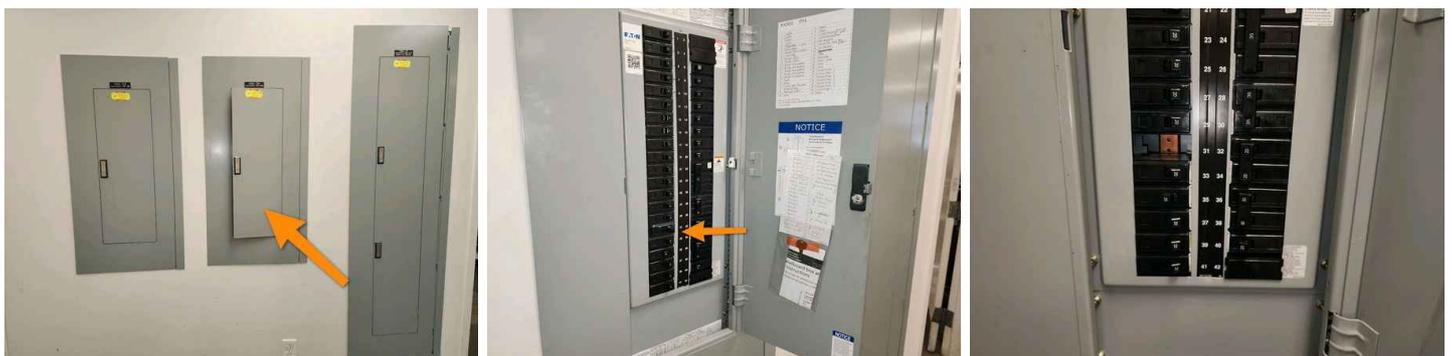
KNOCKOUTS MISSING

"Knockouts" are missing on the electric panel. This poses a safety hazard and it is recommended that the opening in the panel caused by the missing knockout(s) be properly sealed.

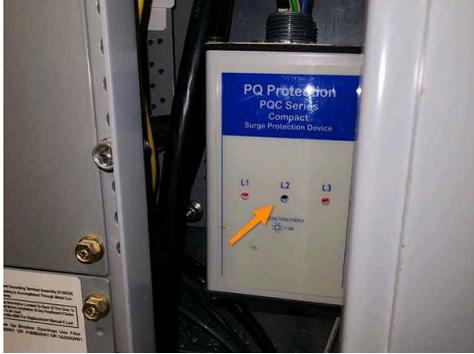
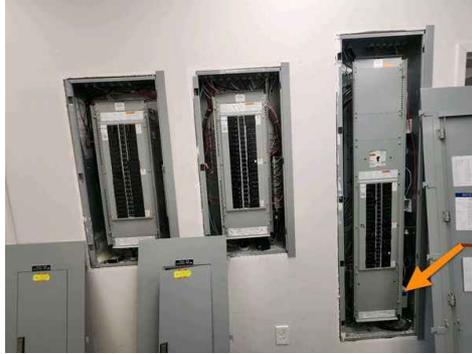
7.2.3 Main & Subpanels, Service & Grounding, Main Overcurrent Device

DEFECTIVE SURGE PROTECTOR

Appears that the surge protection is not functional at the connection for L2. Electrician repair/replace as needed

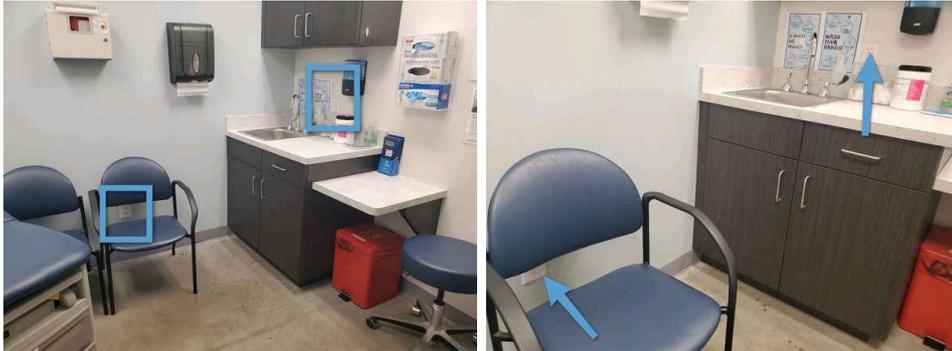
11.7.1 Lighting Fixtures, Switches & Receptacles

LOOSE RECEPTACLES

The receptacles and the gfci receptacle this area(exam room 3)are not secured to the walls/electrical boxes. This makes it easier for the wires to work loose. Recommend adding/tightening screws to better secure the receptacles to the walls.

Exam room 3

Contact a handyman or DIY project

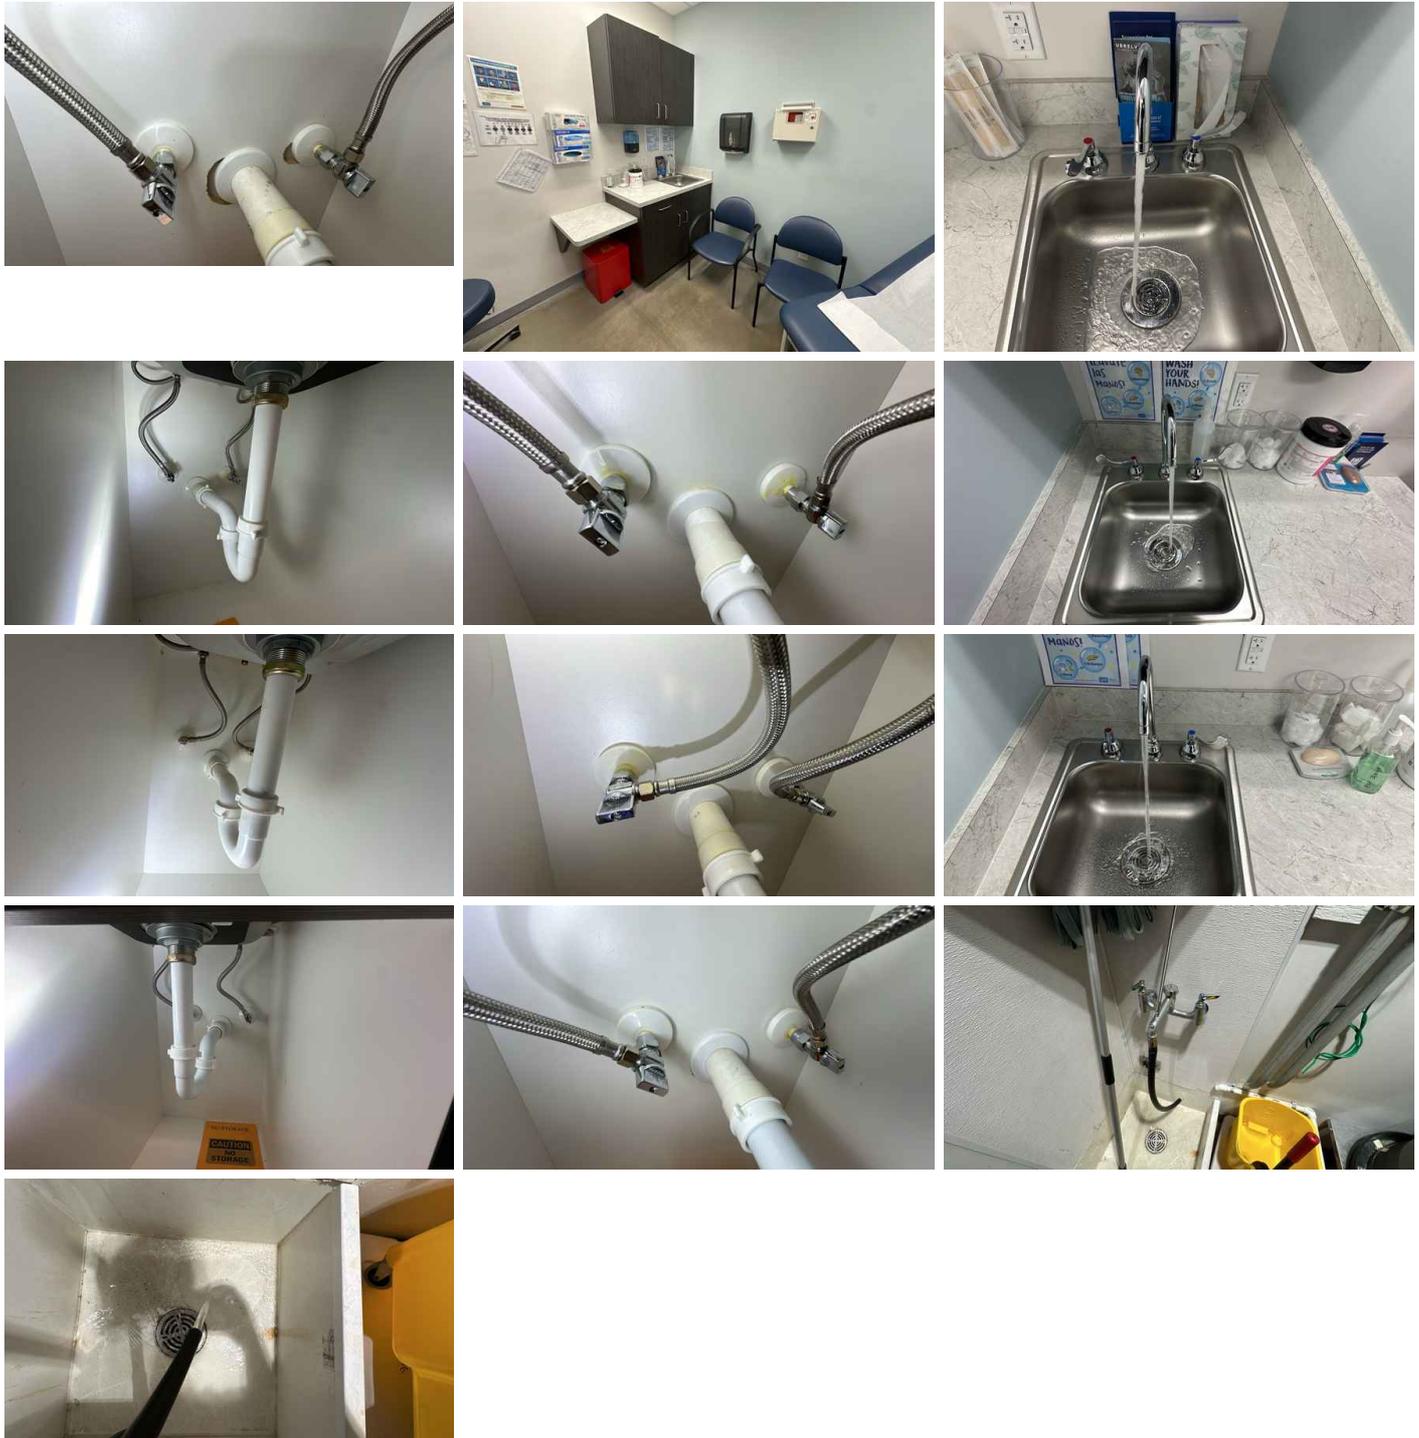
12.3.1 Sink/Vanity

LOOSE FAUCET

The faucet for this sink is loose. Recommended tightening the nuts that are connected to the faucet under the sink to prevent future damage or water intrusion.

Contact a handyman or DIY project

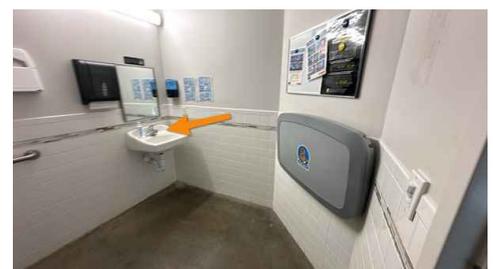
12.3.2 Sink/Vanity

During the time of inspection, there was a dirty screen/aerator in this area and this can cause **low water pressure**. Recommend cleaning/replacing of the screen to return to normal function. If cleaning aerator does not improve pressure, then contact a plumber to evaluate. Sometimes changing faucet is the best remedy.

Contact a handyman or DIY project

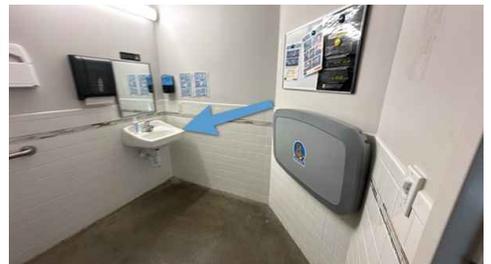
12.4.1 Water Supply, Distribution Systems & Fixtures

CORRODED CONNECTIONS UNDER THE SINK

At the time of inspection, corroded connections or scale buildup were noted. These fittings should be cleaned with CLR and a wire brush to prevent further deterioration.

Contact a handyman or DIY project

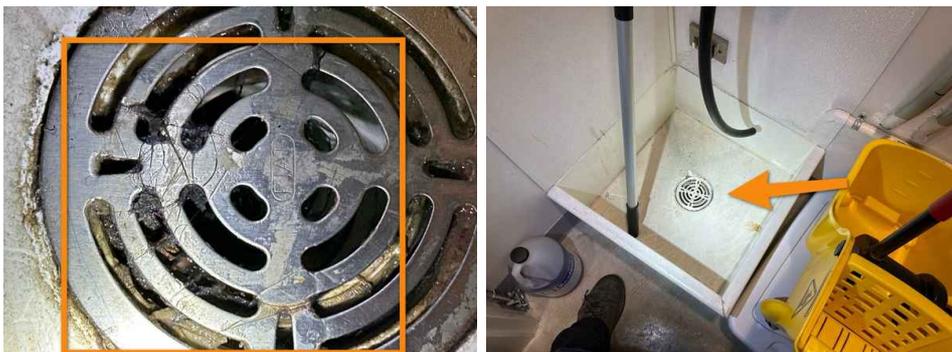
12.8.1 Floors

At the time of this inspection, I noticed an area of old staining, microbial growth and old caulking that's cracking. I recommend cleaning this area with vinegar or bleach water solution. Remove the old caulking and recaulk these areas to prevent water intrusion. A qualified handyman can evaluate and advise repairs as needed.

Contact a qualified professional.

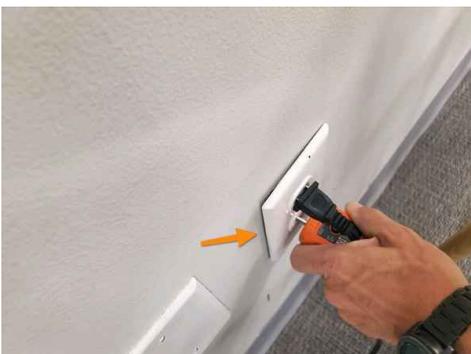
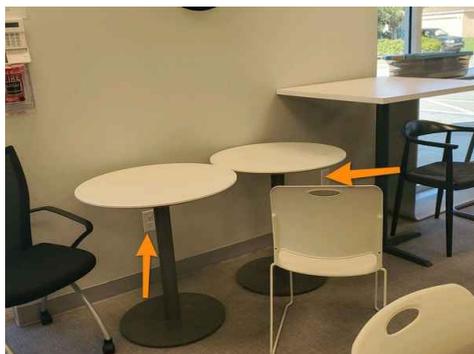
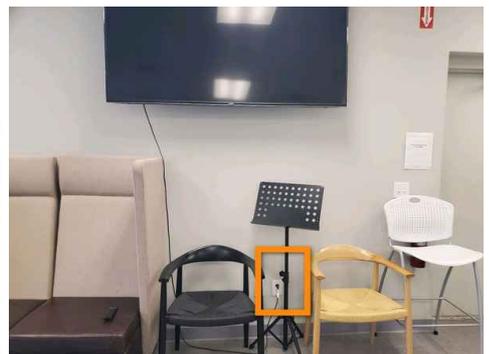
LOOSE RECEPTACLES

Most of the receptacles in the community room and Restaurant are not secured to the walls tightly, making it easier for the wires to be exposed. Recommend tightening screws so the receptacles function properly.

Most receptacles in the community room

Contact a handyman or DIY project

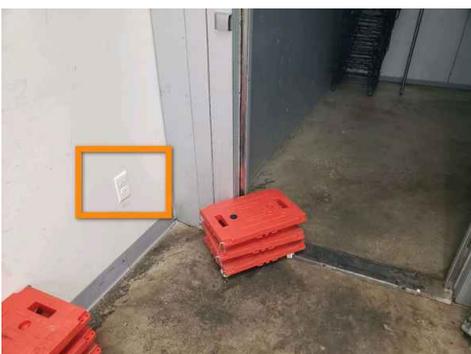
Most receptacles in the restaurant area Restaurant

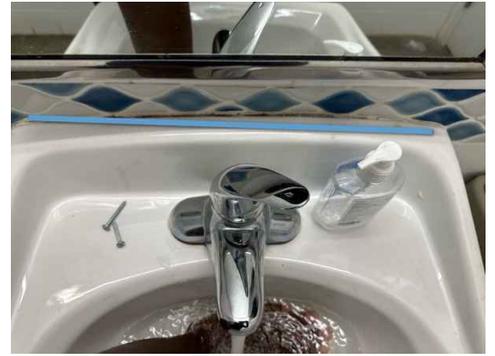
14.3.1 Sink/Vanity

This area should be caulked to prevent water intrusion. Recommend a fresh bead of caulk. noted for your information.

Contact a handyman or DIY project

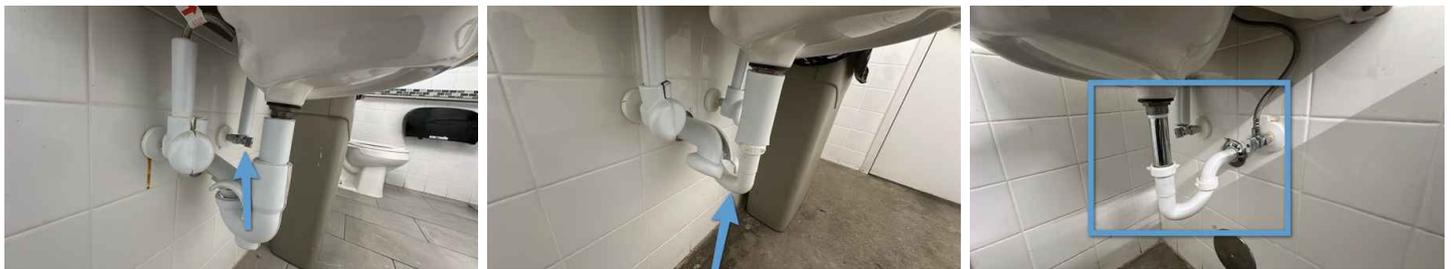
14.3.2 Sink/Vanity

MISSING HANDICAP COVER

At the time of this inspection, one or more plumbing connections or supply lines is missing a handicap cover to protect the plumbing and the disabled. A qualified handyman can evaluate and advise repairs as needed.

Contact a handyman or DIY project

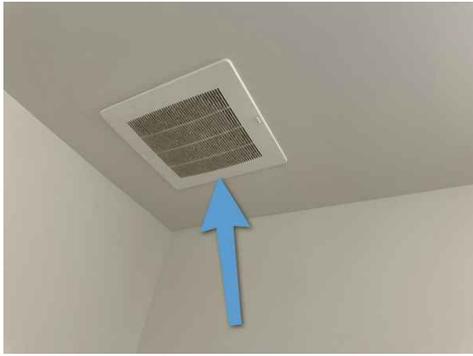
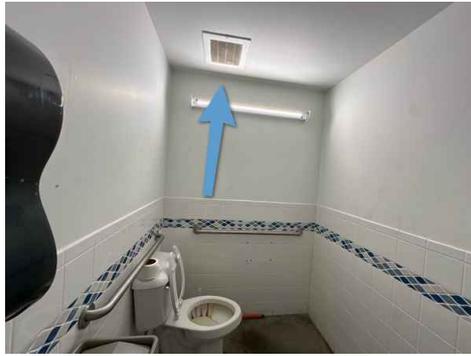
14.7.1 Windows/Vent

DIRTY EXHAUST FAN

During the time of inspection, the exhaust fan was dirty. Recommend cleaning to return to normal operation.

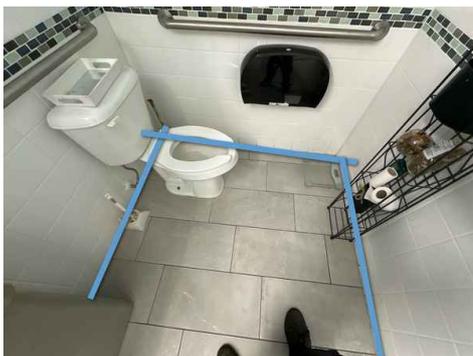
14.8.1 Floors

At the time of this inspection, I noticed the caulking is deteriorating and will need to be removed and recaulked again to prevent water intrusion. A qualified handyman can evaluate and advise repairs as needed.

Contact a handyman or DIY project

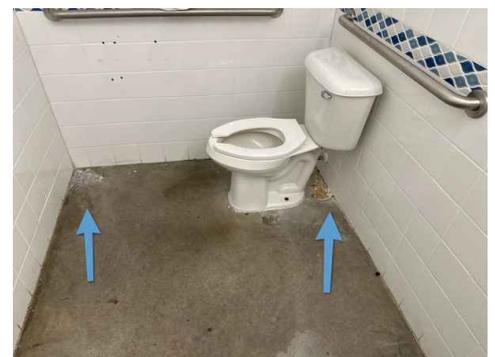
14.8.2 Floors

MINOR DAMAGE

At the time of this inspection, I noticed minor cosmetic damage to the concrete floor behind the toilet and staining. This is cosmetic and I am just noting this for your information. A qualified flooring contractor can evaluate and advise repairs as needed.

Contact a qualified flooring contractor

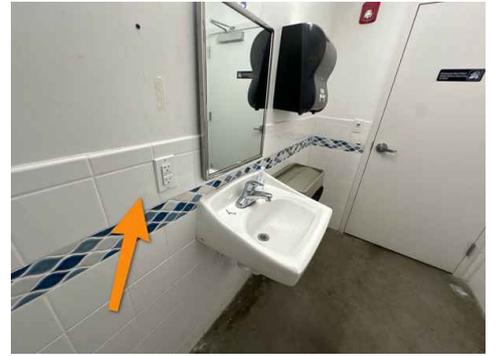
14.11.1 Lighting Fixtures, Switches & Receptacles

LOOSE GFCI RECEPTACLE

The receptacle is not secured to the wall properly making it easier for the wires to be exposed. Recommend this unit be secured to the wall correctly.

Contact a handyman or DIY project

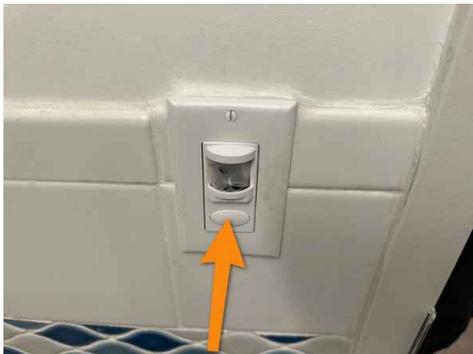
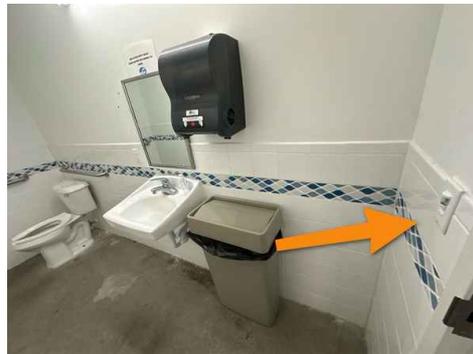
14.11.2 Lighting Fixtures, Switches & Receptacles

DAMAGED SENSOR FOR WALL SWITCH

At the time of this inspection, I noticed the sensor on the wall switch for the women's bathroom is damaged. I recommend replacement of this switch.

Contact a handyman or DIY project

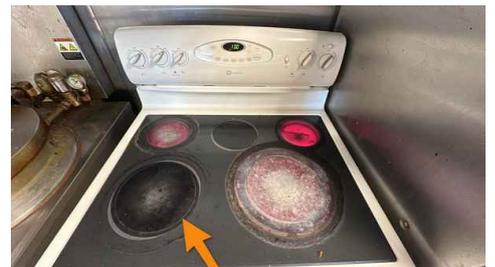
15.2.1 Range/Oven/Cooktop

BURNER NOT HEATING PROPERLY

The heating elements did not heat properly for burner when turned on. Recommend qualified appliance technician evaluate & repair.

Contact a qualified appliance repair professional.

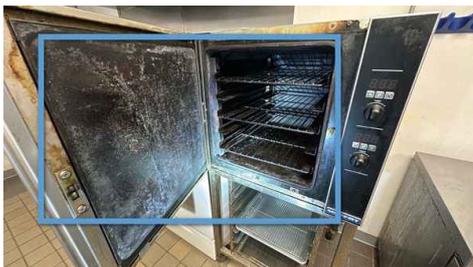
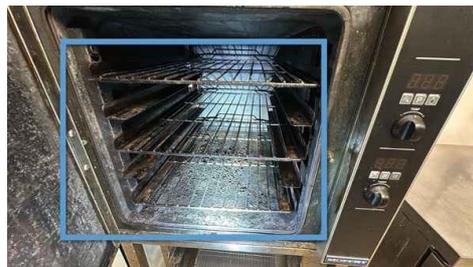
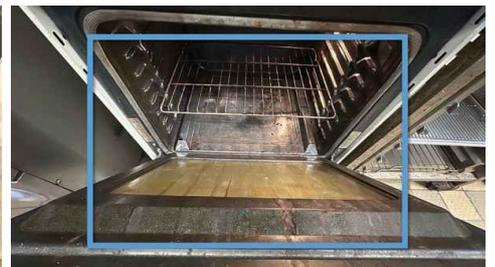
15.2.2 Range/Oven/Cooktop

OVEN EXTREMELY DIRTY

Oven is extremely dirty. Recommend thorough cleaning to prevent oven/ grease fire.

Contact a handyman or DIY project

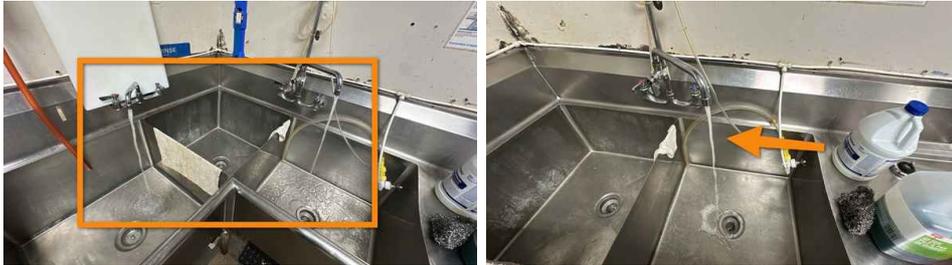
15.5.1 Countertops, Cabinets & Sink

At the time of this inspection, the pressure was weak coming out of the sink faucet. This is most likely from a dirty or partially clogged aerator/screen. I recommend removing the aerator/screen and soaking it in CLR solution to see if it removes any of the buildup. A qualified plumbing contractor can evaluate and advise repairs as needed.

Contact a qualified plumbing contractor.

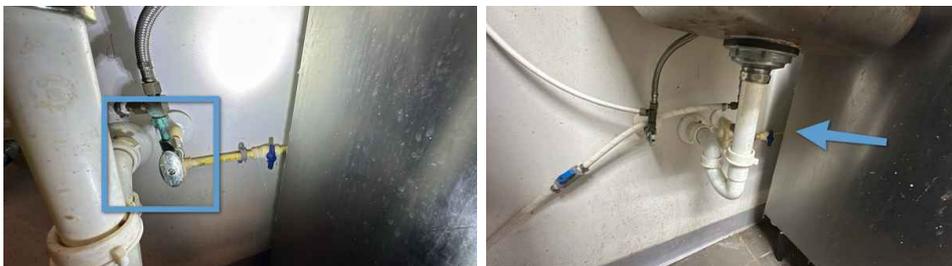
15.7.1 Water Supply, Distribution Systems & Fixtures

**CORRODED CONNECTIONS UNDER THE SINK**

During the time of inspection normal corrosion was noted at the plumbing connections under the sinks. This can lead to shortened lifespan of the pipe. Recommend cleaning these pipes with CLR, a wire brush or sandpaper to prolong the life of the pipes.

Contact a handyman or DIY project

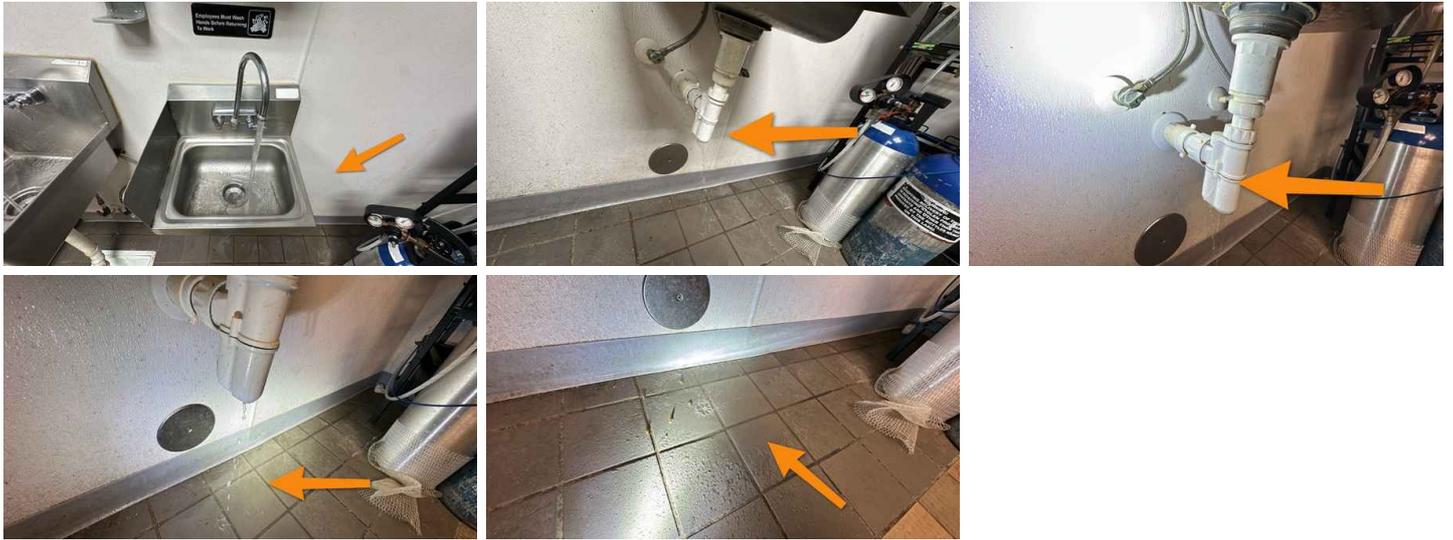
15.8.1 Drain, Waste, & Vent Systems

**LEAKING PIPE**

A drain, waste and/or vent pipe showed signs of a leak. Recommend a qualified professional evaluate and repair.

Contact a qualified professional.

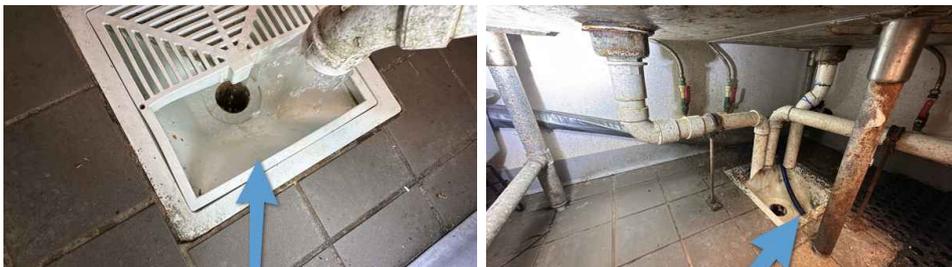
15.8.2 Drain, Waste, & Vent Systems

MISSING DRAIN CAP

At the time of this inspection, the drain caps are missing to prevent debris from entering the drain and causing a blockage. I recommend adding the drain caps during your normal routine maintenance.

Contact a handyman or DIY project

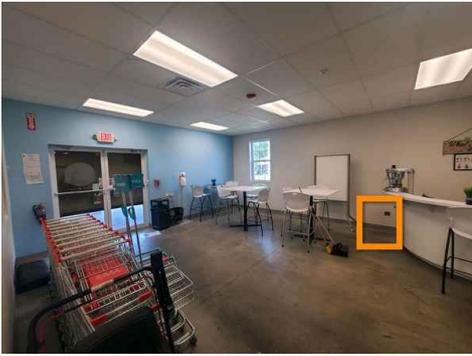
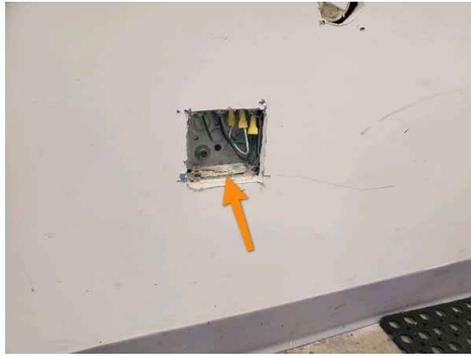
15.9.1 Lighting Fixtures, Switches & Receptacles

COVER PLATES MISSING

One or more receptacles are missing a cover plate. This causes short and shock risk. Recommend installation of plates.

Contact a handyman or DIY project

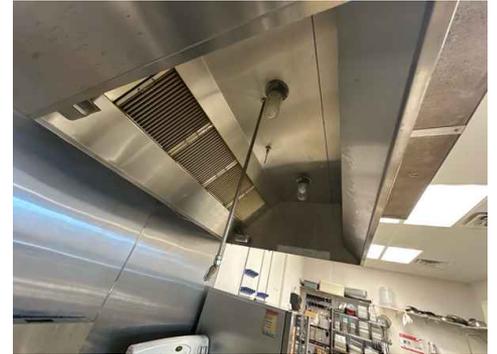
15.9.2 Lighting Fixtures, Switches & Receptacles

LIGHTS INOPERABLE

Lights not operating in this area. New light bulb possibly needed. If new bulbs do not solve the issue recommend a qualified electrician evaluate and advise.

Contact a handyman or DIY project

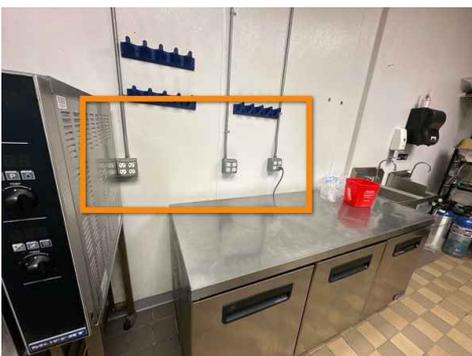
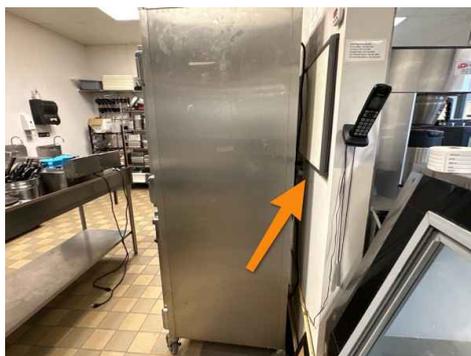
No GFCI protection present in all locations for kitchen. If updated, we Recommend licensed electrician/ professional upgrade by installing ground fault receptacles in all locations.

Contact a qualified electrical contractor.

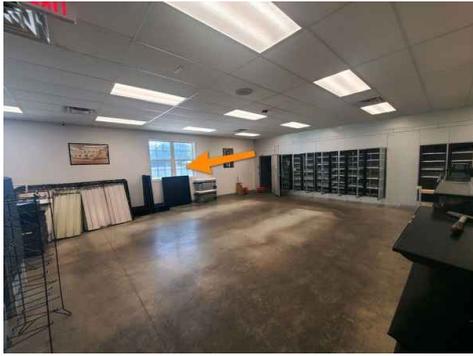
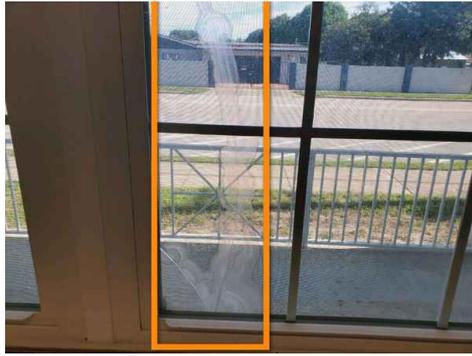
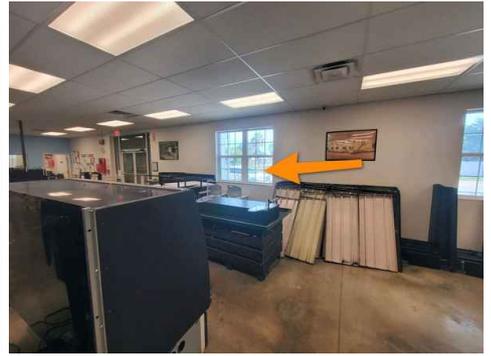
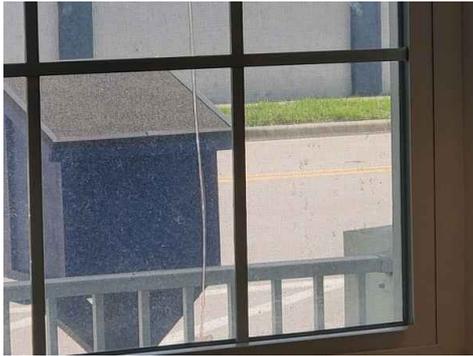
15.11.1 Windows

CRACKED GLASS AND FAILED SEAL

Observed condensation between the window panes, which indicates a failed seal. I also noticed two cracked glass where the failed seal is present. I Recommend qualified window contractor evaluate & replace.

Contact a qualified window repair/installation contractor.

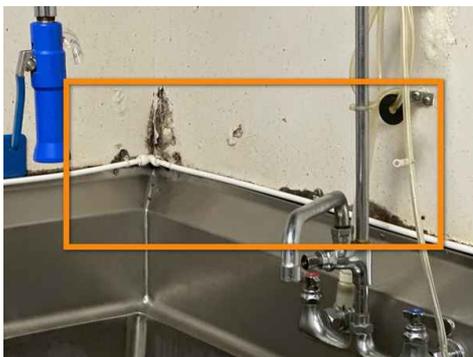
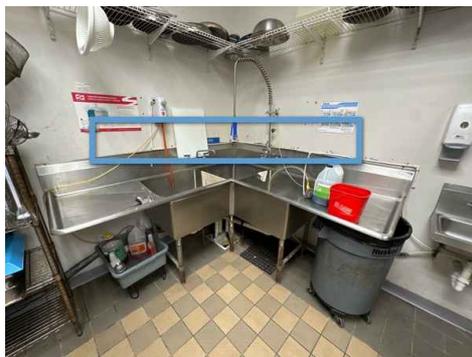
15.13.1 Walls

MICROBIAL GROWTH NOTED

At the time of this inspection, I noticed black microbial growth forming in the back wall of the kitchen sinks. Microbial growth can form on any surface in an environment that lacks sufficient ventilation or has high levels of humidity. Also with water splashing on the wall and not being wiped down after is also contributing to microbial growth. Clean these areas with vinegar or bleach water solution.

Contact a qualified professional.

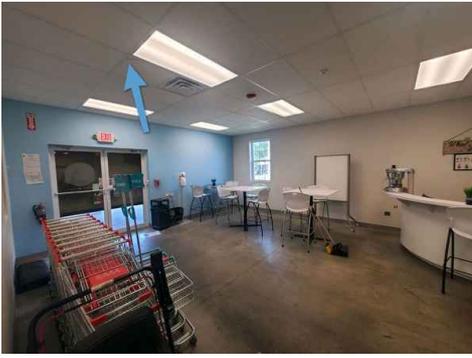
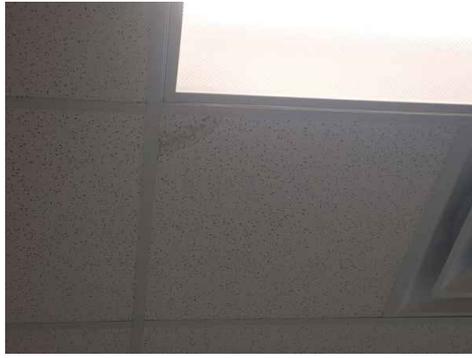
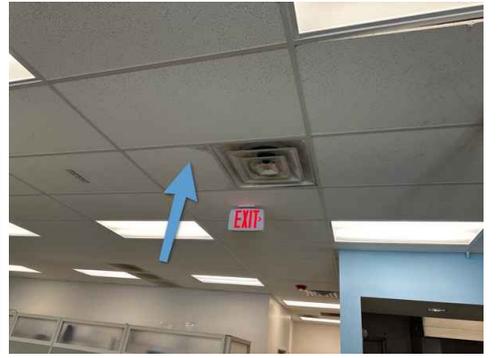
STAIN(S) ON CEILING

There is a stain on ceiling that requires paint. Source of staining should be determined if stain spreads. Tested dry at the time of inspection.

Contact a handyman or DIY project
